# Illicit Discharge Detection and Elimination (IDDE) in Racine – a Case Study

"TECH Water Star Wisconsin Express Webinar #7 - Illicit Discharge"

November 29, 2012

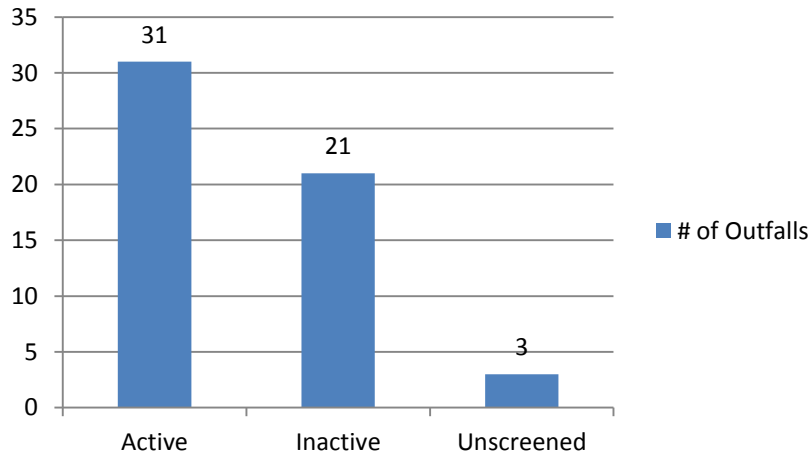
## Summer 2005 Status of Outfalls

- 55 Outfalls Identified for Screening
  - 31 Outfalls Active
    - 21 Outfalls with exceeded threshold limits (6 with 2 parameters)
      - 12 Detergents ( $\geq 0.25$  mg/l)
      - 10 Chlorine ( $\geq 0.2$  mg/l)
      - 5 Copper ( $\geq 0.1$  mg/l)
      - 0 Phenols ( $\geq 0.5$  mg/l) – (later reduced to  $\geq 0.1$  mg/l)

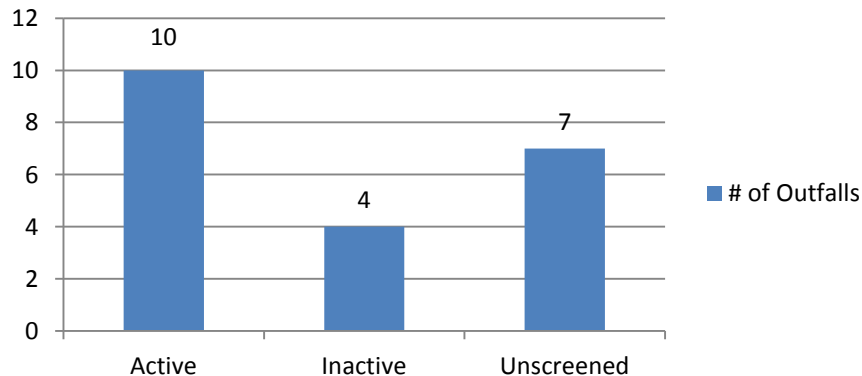
**Fall 2005 Status of Outfalls**

- 21 Outfalls Identified for Screening
  - 10 Outfalls Active
    - 8 Outfalls exceeded thresholds (1 with 2 parameters)
      - 4 Detergents
      - 4 Chlorine
      - 1 Copper
      - 0 Phenols
  - Good Correlation to Prior Results for Active Outfalls

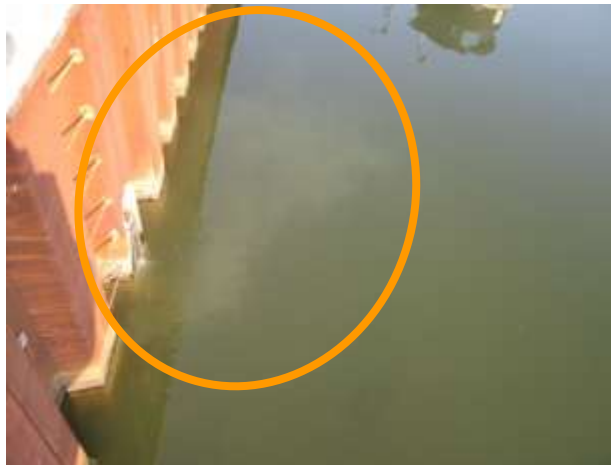
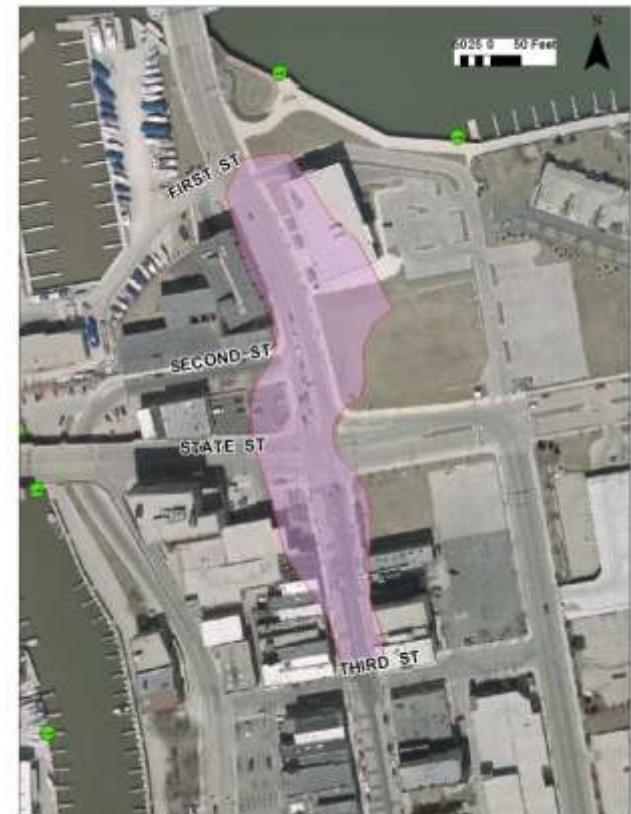
# Basin RR57 (2005)

- “Minor Outfall” - Basin RR57
- Wet – variable ‘milky’ flow (with floatables)
- Tested positive for detergents and copper
- Reported to City following observation
- Utilized City televising contract
- Identified improper direct connection
- Recent Redevelopment Project
- Notified owner
- Owner corrected

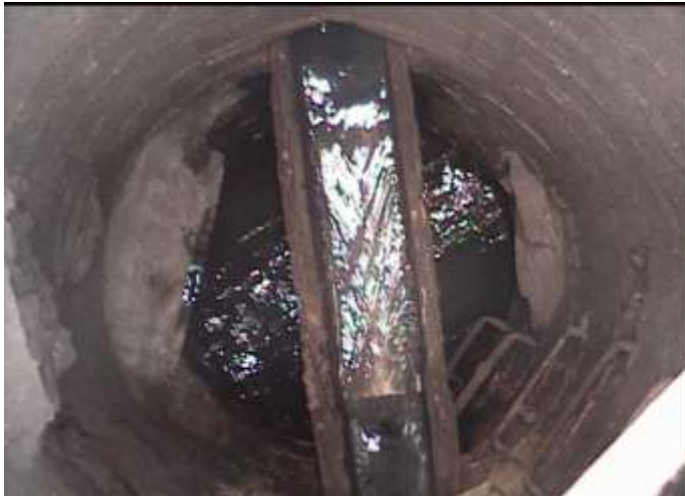
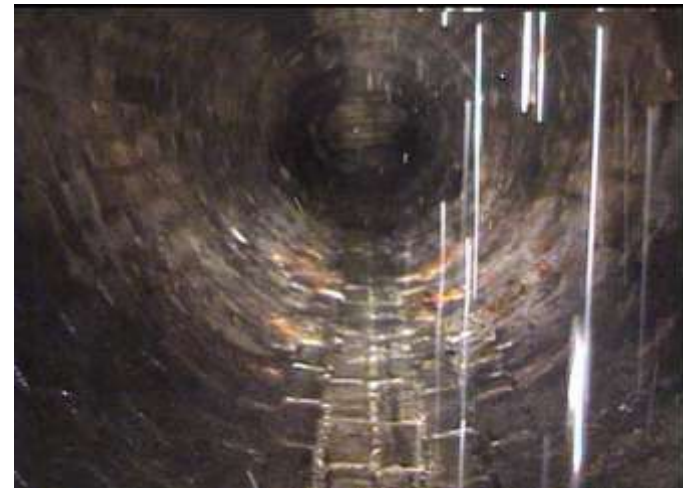
# Basin RR61 (2006)

- Upstream system investigations identified illicit discharge
- Sanitary system 'direct' cross connection
- City corrected connection deficiency
- E. Coli levels persisted

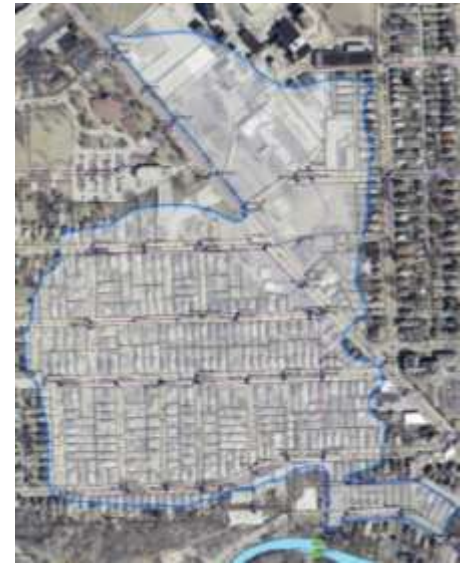
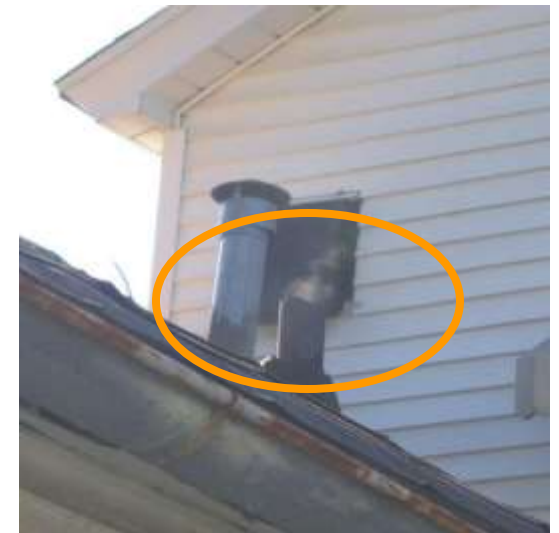
# Basin RR61 (2007)

- Exceeded detergents
- E. Coli >10,000 mpn in 5 of 7 samples
- Upstream investigation led to isolation of sewer segment
- Smoke testing showed lateral connections
- Dyed water test verified location and number of connections
- CCTV indicated indirect connections (leaking sanitary sewer laterals)
- Laterals under private ownership

- E. Coli dropped in subsequent tests

- City relocated storm sewer
- City established sanitary sewer maintenance fee and took responsibility for laterals from property line to main connection

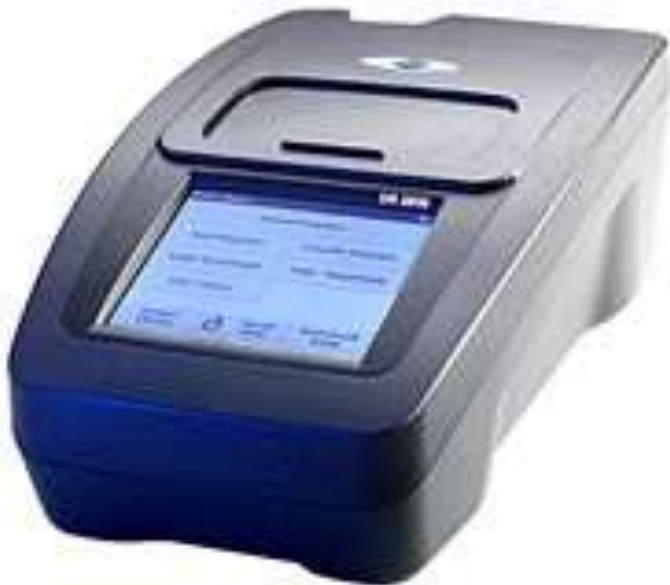
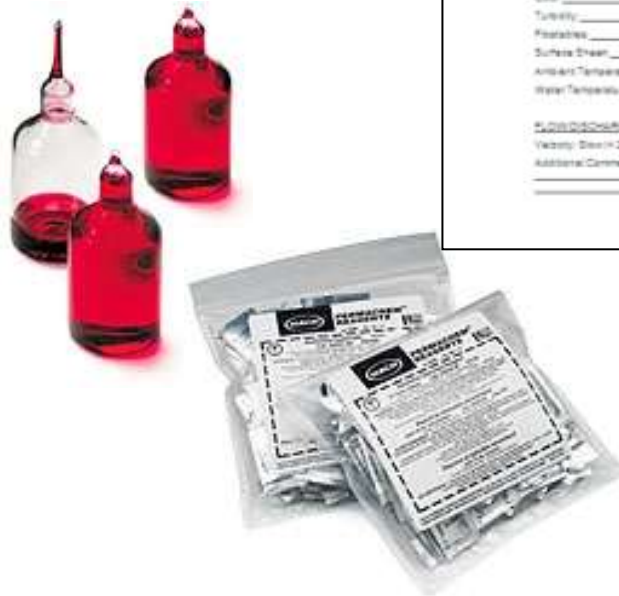
- Continued IDDE Program Evolution
  - HACH Spectrophotometer
  - Modified parameters
    - potassium (>3.1 mg/l)
    - fluoride (>0.25 mg/l)
    - ammonia (>0.1 mg/l)
  - CHEMetrics detergents (>0.5 mg/l)
  - Added Bacteroides

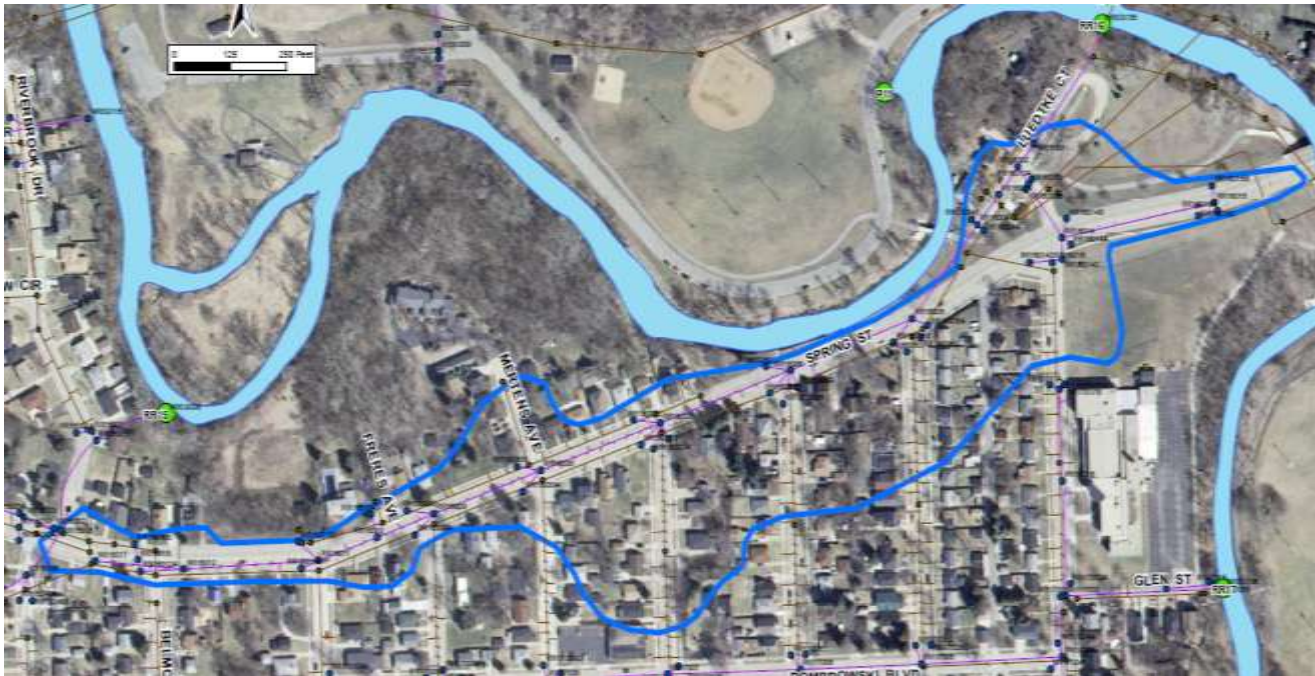
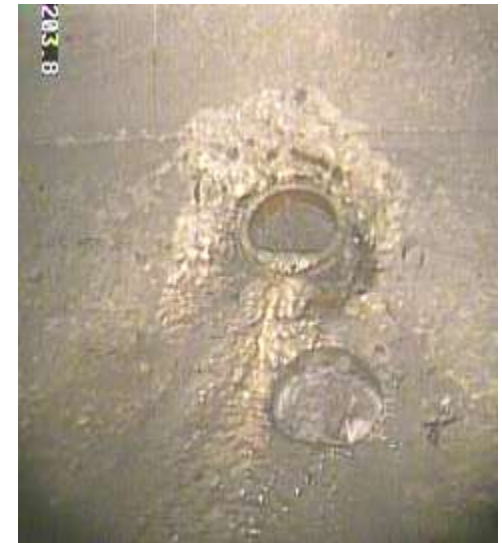
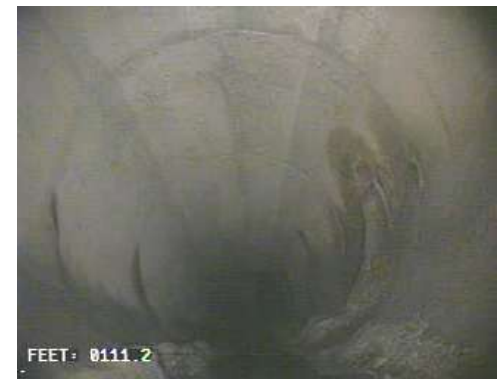
# City of Racine Basin RR16 (2010-2012)

- 2005/2006 routine screening – inactive/standing water
- Elevated E. Coli
- CCTV showed deposits, seeping taps, debris, standing water
- 2011/12 – Bacteroides <5,000 CN/100ml in 9 of 10 samples
- Typically < 1% of all Bacteroides present (BUT up to 3% at times)

- Remains on “watch list”

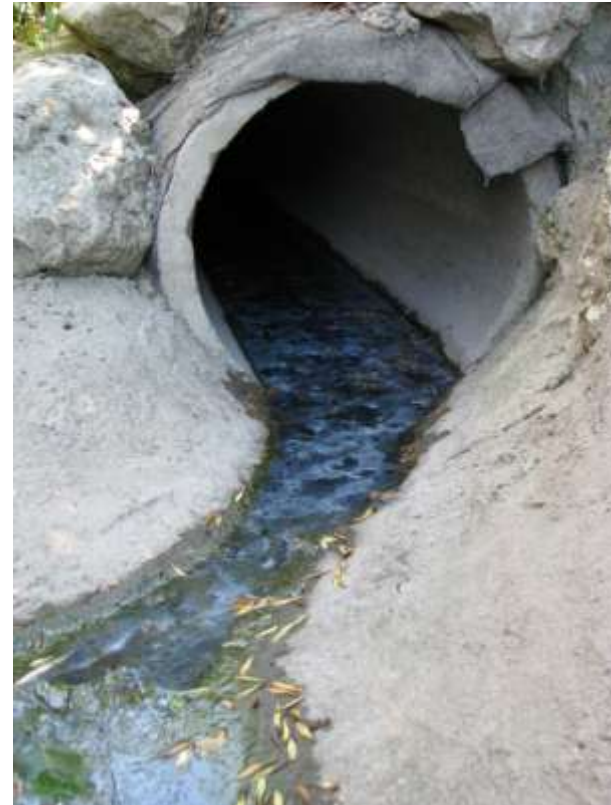
# Basin RR23 – Liberty Street (2011-12)

- Investigation History
  - “Minor Outfall”
  - 2011 Health Dept. found elevated E. Coli in River, traced to outfall
  - Fluoride = 0.7 mg/l
  - Detergents = 1 – 7.5+ mg/l
  - Potassium = 3.0 – 7.6 mg/l
  - Ammonia = above limits of test
  - E. Coli > 10,000 mpn
  - Bacteroides (BacHuman) = 400,000-58,000,000 CN/ml  
(7 – 48% of total Bacteroides)
  - Dye test/CCTV confirmed direct connection of sanitary sewer lateral to storm sewer (legacy of combined sewer separation)
- Corrective Action
  - Disconnect sanitary sewer lateral
- Follow-up Results
  - Dry in virtually all visits
